Service Bulletin 2017-002

Issue Date: October 2, 2017

Subject: Ring position on SIFE main risers

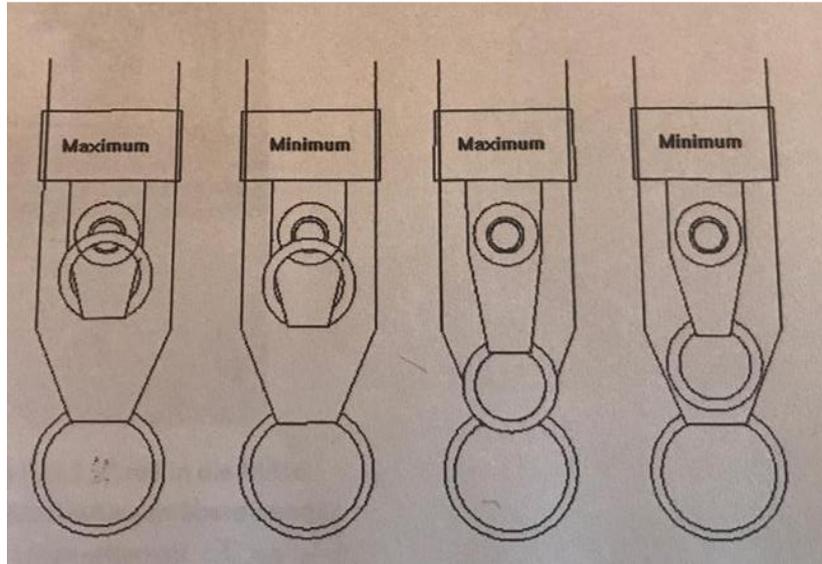
We have been informed that during the simulation of a cutaway procedure, the 3-ring-system released only after a short tug on the risers. The result of our investigations is that the position of the small ring on the affected main risers may not meet the design specifications.

1. Check the ring position on your main risers with the following figure:

2. If your main risers do not meet the design specifications, or if you are unsure please send us an e-mail to office@sife.at.

The main riser replacement will be free of charge.
